**MANDATORY**  
**SERVICE BULLETIN**  
**MSB-2009-001**

**DATE:** August 31, 2009

**SUBJECT:** Revised Support Clamps

**MODELS AFFECTED:** All Cessna 177RG aircraft with PFS-13706 exhaust systems installed (See Table 1 for Aircraft Applicability).

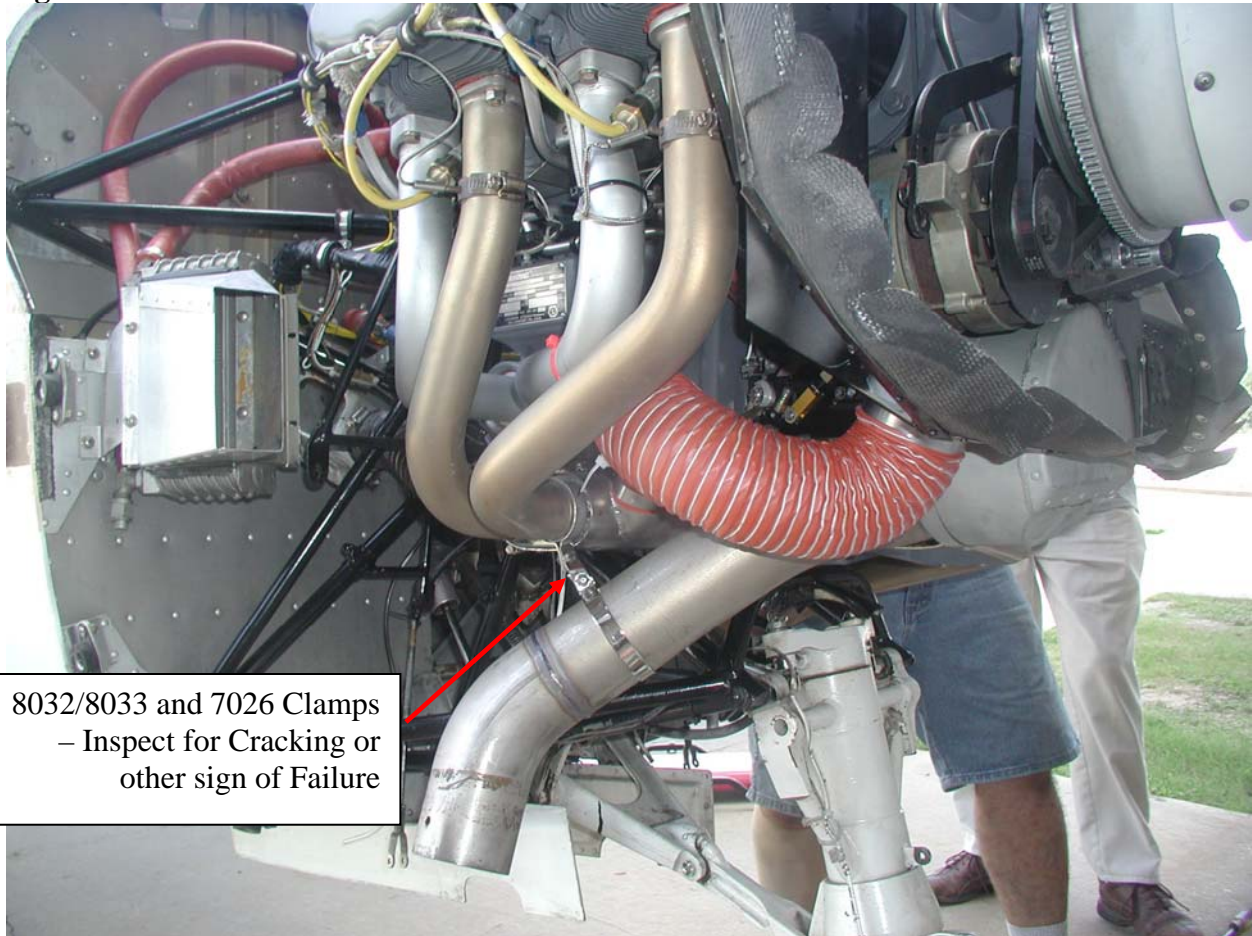
**Figure 1**

**DESCRIPTION:** In the short time since the introduction of this exhaust system, there have been several failures of the P/N 8032 and 7026 clamps that attach the intermediate tube to the number one header pipe. While this is not the only means of securing the intermediate tube to the rest of the exhaust system, the clamp does help ensure proper tailpipe angle. The original clamps were 0.63" wide.

We have developed two wider (1.00" wide) replacement clamps (P/N 8033 and 7026 Rev A) and will be providing them free of charge to all affected customers. Please inspect both clamps before your next flight, looking for cracking or detachment. If either clamp is cracked or has otherwise failed, replace both with the new clamps before further flight. If the clamps are not cracked or otherwise damaged, you may continue to use them until the next scheduled maintenance (oil change, annual, etc.). If you elect to continue to use the clamps, note how much tailpipe movement is present. If a future preflight inspection yields more tailpipe movement, the clamps should again be inspected.

**CORRECTIVE ACTION:** Install the clamps included with this Service Bulletin.

Remove the existing clamps by removing the hardware that joins them. Install the new clamp in the same manner as the original, discarding the old clamp. Please keep in mind that if you did not receive two clamps, you will need to reuse the 8033 clamp (the larger of the two). It may be necessary to pull forward on the bottom of the intermediate tube while tightening the clamps to ensure sufficient clearance to the engine mount. See the included installation instructions for additional details. Make a logbook entry stating that you have complied with this service bulletin.
