**MANDATORY**  
**SERVICE BULLETIN**  
**MSB-2009-001**

**SUBJECT:** Revised Support Clamps

**MODELS AFFECTED:** All Cessna 177RG aircraft with PFS-13706 exhaust systems installed (See Table 1 for Aircraft Applicability).

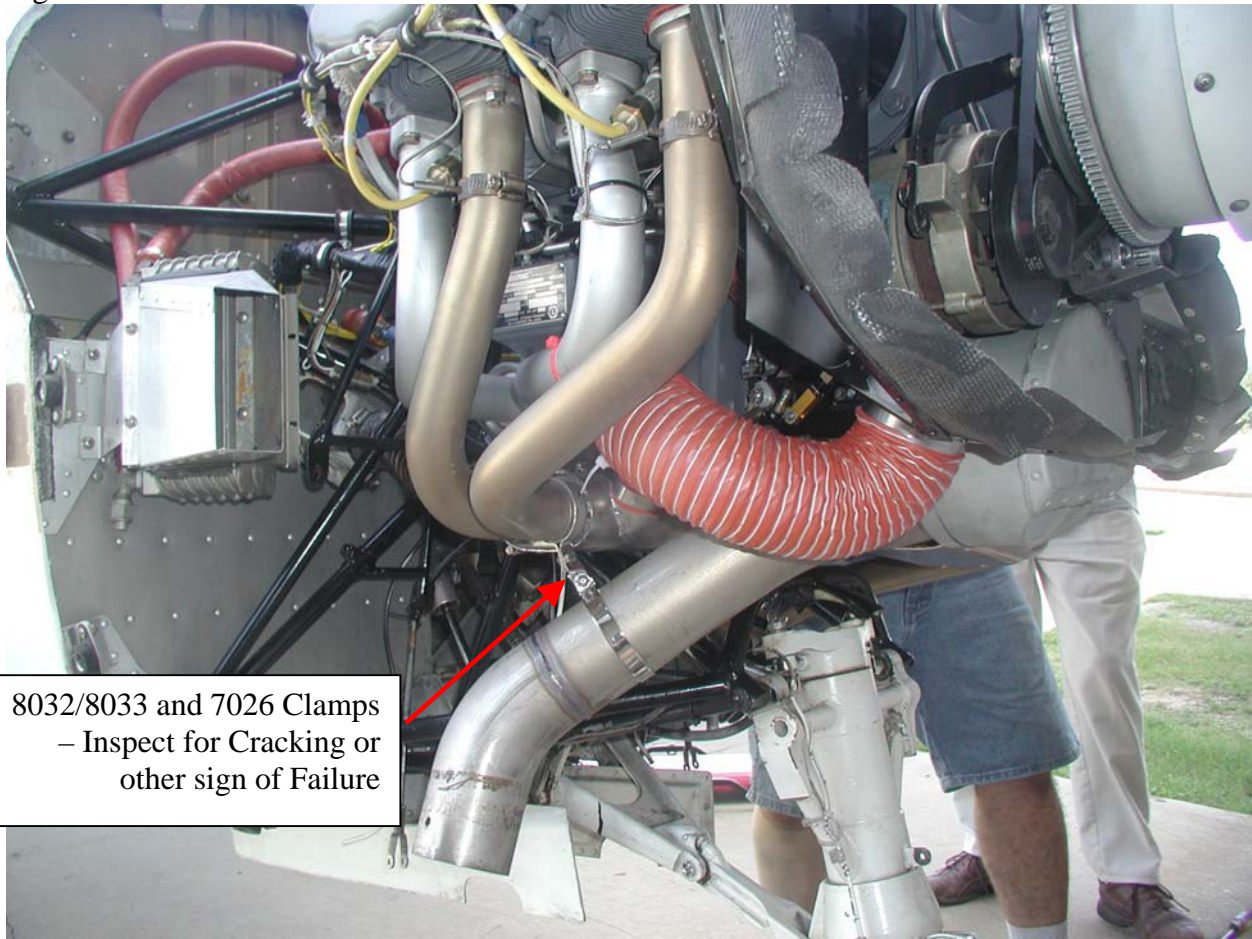
Figure 1

**DESCRIPTION:** In the short time since the introduction of this exhaust system, there have been several failures of the P/N 8032 and 7026 clamps that attach the intermediate tube to the number one header pipe. While this is not the only means of securing the intermediate tube to the rest of the exhaust system, the clamp does help ensure proper tailpipe angle. The original clamps were 0.50" wide\*.

**CORRECTIVE ACTION:** Install the clamps included with this Service Bulletin.

Remove the existing clamps by removing the hardware that joins them. Install the new clamp in the same manner as the original, discarding the old clamp. Please keep in mind that if you did not receive two clamps, you will need to reuse the 8033 clamp (the larger of the two). It may be necessary to pull forward on the bottom of the intermediate tube while tightening the clamps to ensure sufficient clearance to the engine mount. See the included installation instructions for additional details. Make a logbook entry stating that you have complied with this service bulletin.
